Guided Biofilm Therapy®: The Optimal Solution for Implant Maintenance

Eunae Kim

Head of the Lifetime Oral Care Center at
Yonsei Wooil Dental Hospital &
Director of KCDHC & SDA Trainer

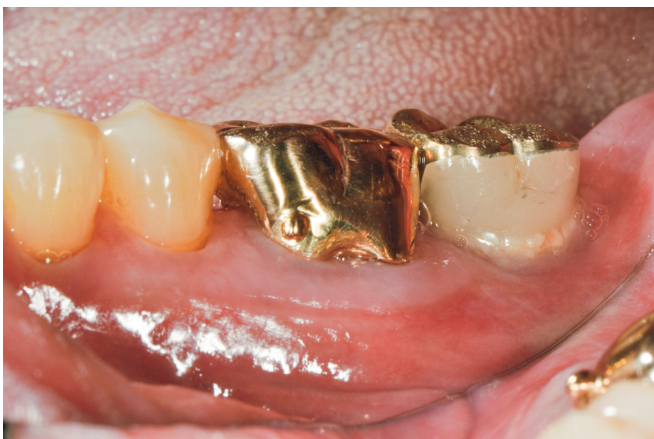
▲ <Plaque observed during subgingival probing on #47I>

During examination, patients with mucositis may show significant subgingival plaque or foreign substances like implant cement. It is important to check for inflammation by assessing bleeding on probing (BOP) and using an explorer (ODU #11/12) for subgingival probing, ensuring no damage is caused to the gingival epithelium and the implant.

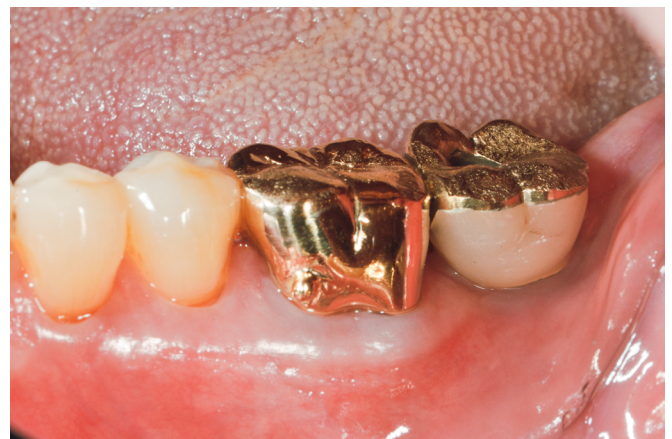
▲ <Stable gingiva observed six weeks after applying AIRFLOW® on #47I>

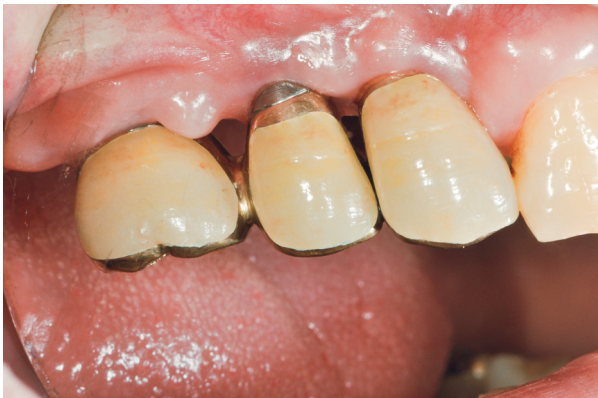
▲ <Image showing gingival swelling and edema around an implant>

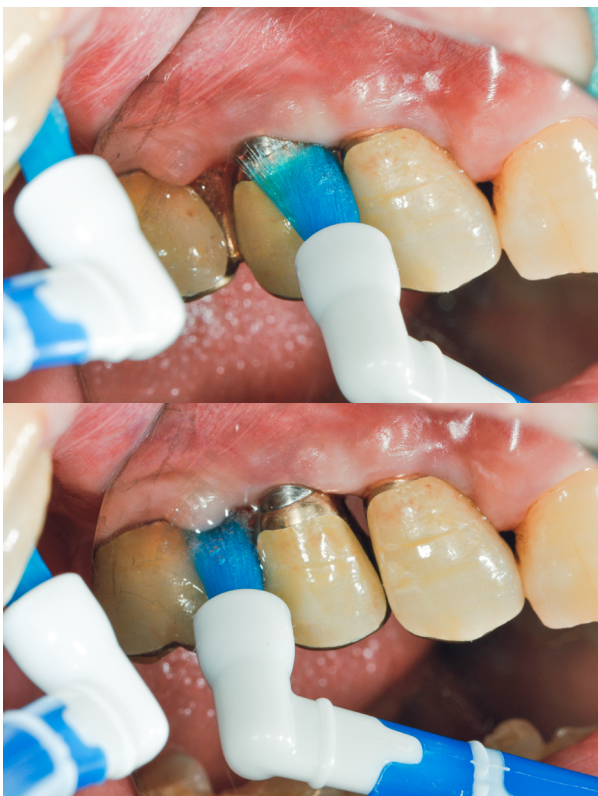
▲ <Image depicting the use of a Perio Brush (GC Korea) to perform TBI on swollen gingiva around an implant>

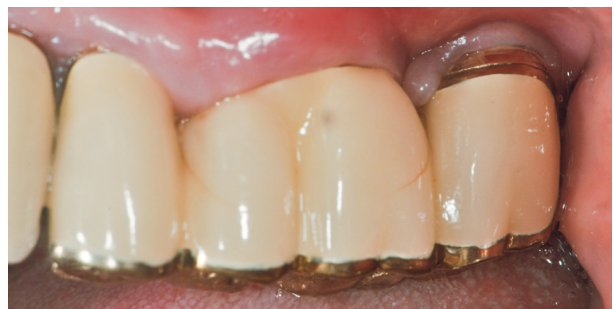
▲ <The state of peri-implantitis during a maintenance visit>

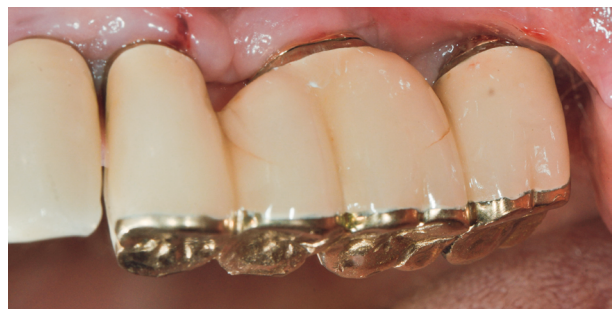
▲ <Improvement one week after periodontal treatment>

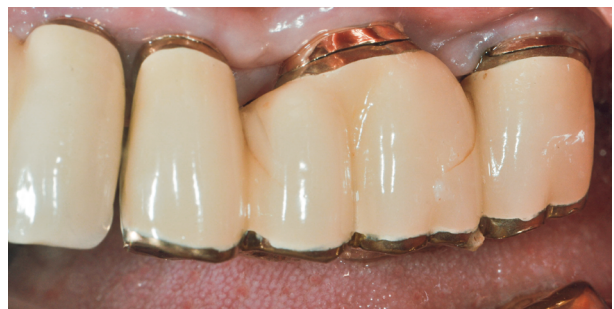
▲ <Stabilized gingiva two weeks after periodontal treatment around the implant>

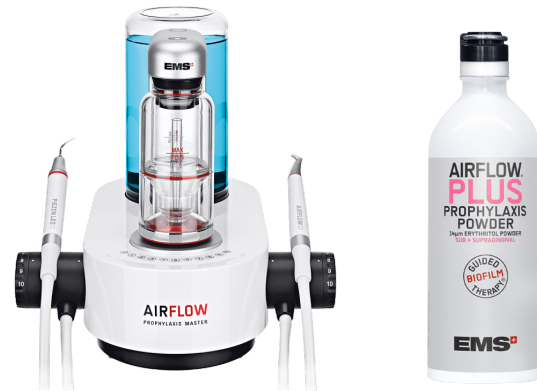
<AIRFLOW[®] Prophylaxis Master> <AIRFLOW[®] Plus Powder>

To enhance implant maintenance, the use of AIRFLOW[®] and Guided Biofilm Therapy[®] (GBT) is becoming increasingly common in dental practices. AIRFLOW[®] Plus Powder, specifically designed for GBT, is erythritol-based and contains chlorhexidine (CHX), offering antimicrobial effects. Its fine particle size allows minimal invasive biofilm removal from hard-to-reach areas, such as between implant prosthetics and fixture threads. When used correctly, it can also be applied subgingivally.

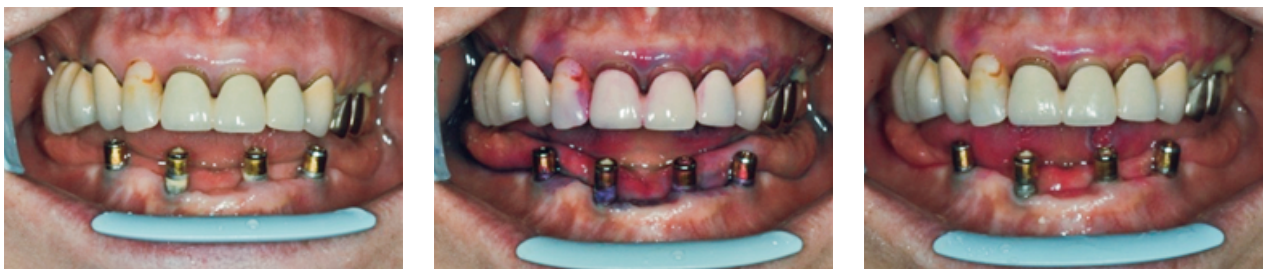
▲ <Example of GBT (Guided Biofilm Therapy) using AIRFLOW[®] MAX>

The GBT protocol begins with assessing the patient's oral condition and risk factors. After evaluating the patient's health, biofilm is disclosed to make it visible, allowing both the patient and clinician to identify well-maintained and neglected areas. This visual feedback is used to engage in motivational counseling and education to improve oral hygiene. The disclosed biofilm and calculus are then effectively removed using AIRFLOW[®] and implant-specific scaler tips, followed by scheduling the patient's next maintenance appointment.

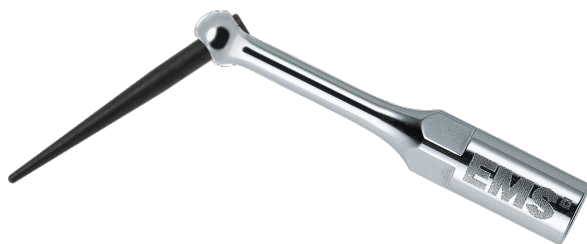
▲ <PI Max scaler tip for implants and prosthetics>

The newly introduced implant-specific scaling tip, PI Max is highly effective for removing calculus around implants. This tip is designed to be slender, like a probe, and is made from carbon-containing PEEK material. It allows gentle insertion up to 3mm subgingivally, enabling maintenance from implant prosthetics to fixtures with minimal risk of damage. This ensures a pain-free experience for patients and makes it easier for clinicians to access hard-to-reach areas around implants.
